Looking towards the future and changing the way we manage our streams

Hydrological Impacts of Increased Runoff on Streams

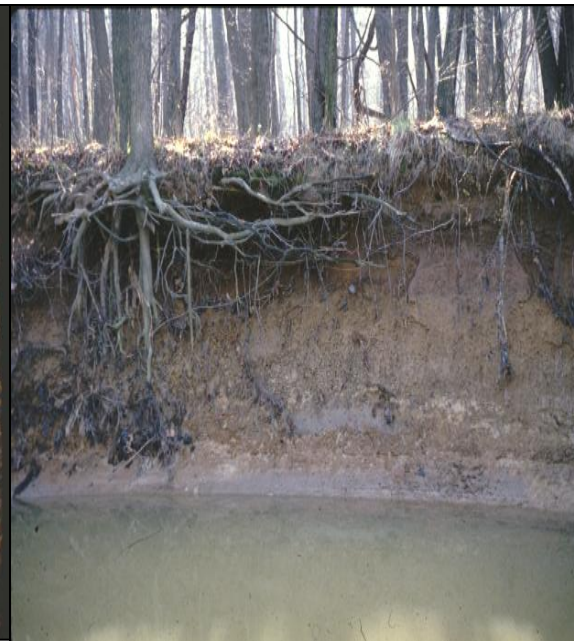
Lower baseflow

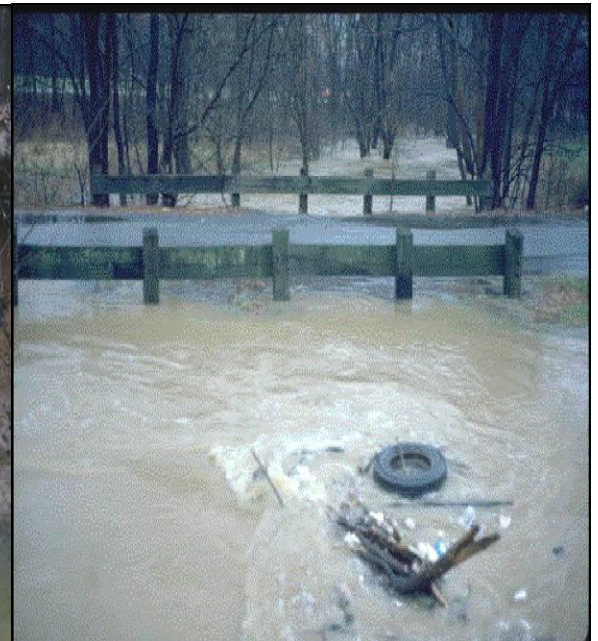
Increased
flood
peaks

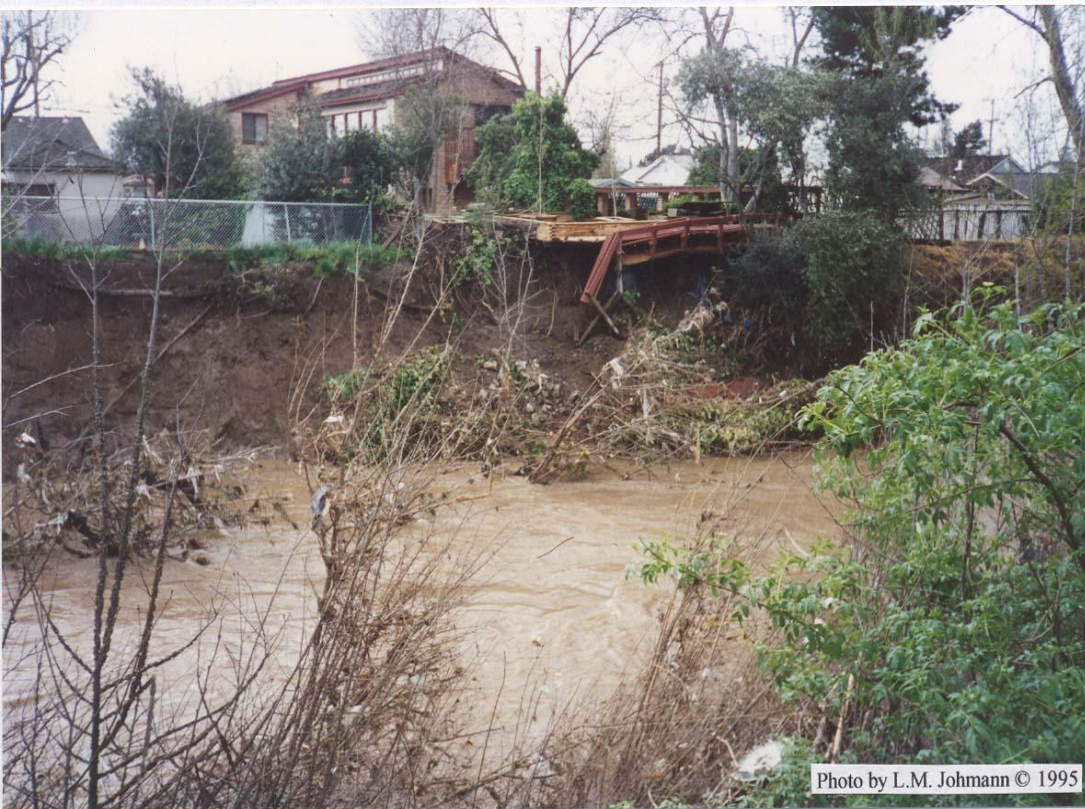
Guadalupe River - San Jose, CA

Erosion

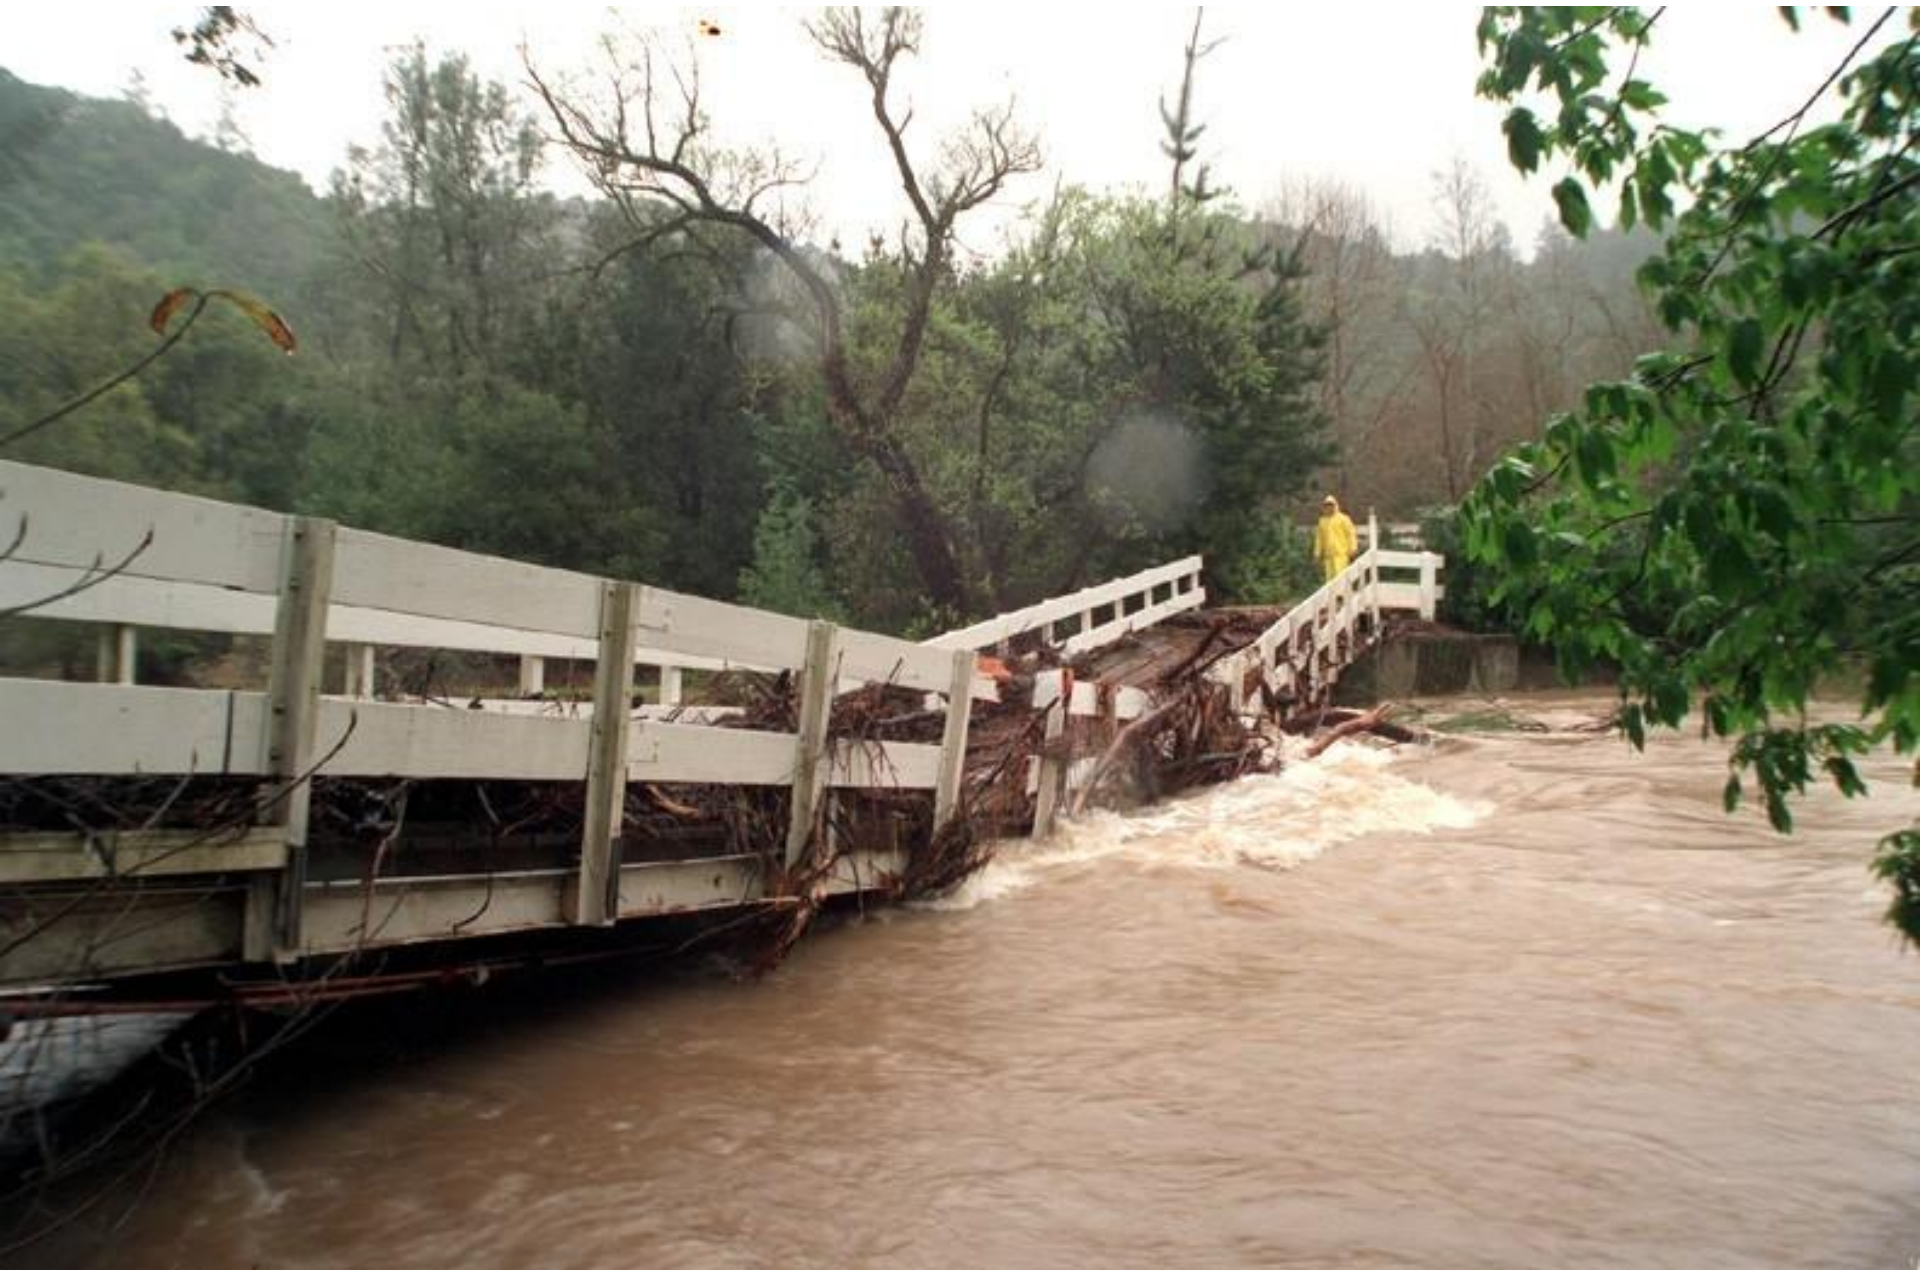
Channel Incision contributes lots of fine sediment
and destroys salmon habitat
